**Flood Control Project Maintenance  
Levee Inspections**  
**LMA District Cover Sheet**  
**Spring 2020 Levee Inspection Results**

**American River Flood Control District**

**Spring 2020 Levee Inspection Results**

Waterway			Bank	Unit Miles
Unit No. 01 Arcade Creek			Left	2.08
	Spring (March - May)	Summer (June - August)	(September - November) Fall	Winter (December - February)
Unit Maintenance Rating (Fall Only)				
Date of Inspection	3/25/2020 - 3/25/2020			
DWR Inspector	Luz Dial			
Accompanied By	Gilbert Gutierrez ARFCD

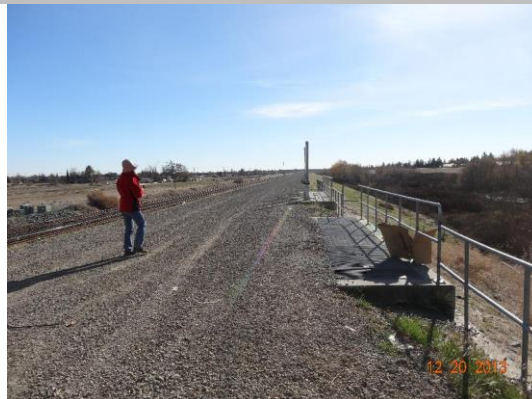
Photo 1 of 3 : UCIP\_SP\_2020\_49862\_52893.jpg

Comment Code						
Inspector Comment						
DS_ID:24608 FS_ID:49862 EP_NO: 9596 Repair Type: Non-Urgent Crossing Status: Indicator Found UCIP Comments: Dense vegetation on waterward side limits inspector's inspection. Recommend removing vegetation. FIELD_STRUCT_DESC: [Sump No. 157] 1 of 3: 54-inch steel drainage pipe through the levee, 3 feet below the crown. Steel cutoff wall around pipe under center of levee. Siphon breaker in protective housing located on the waterside (WS) shoulder. Concrete headwall and flap gate located on the WS end. Trench on WS. Pumping plant located on the landside (LS). On March 28, 1995, the Sacramento City Council adopted Resolution No. 95-123 authorizing the execution of Agreement No. 95-065 regarding the transfer of drainage facilities that include Pump Station 7 as described by ARFCD and described by the City of Sacramento as Sump 157. (three 54-inch pipes installed in the siphon breaker structure but only one pipe installed through levee under Permit No. 9596, 9596-A, and 1975 - American River Flood Control District; second pipe installed through levee under Permit No. 9596-B, 1980 - American River Flood Control District; name change completed under Permit 9596-1 (includes work authorized under Permit No. 9596, 9596-A, and 9596-B), 2016 - City of Sacramento) [Additional Reference(s): DWR Levee Log, 2002] FS Date: 12/20/2013

Overview of levee crown.

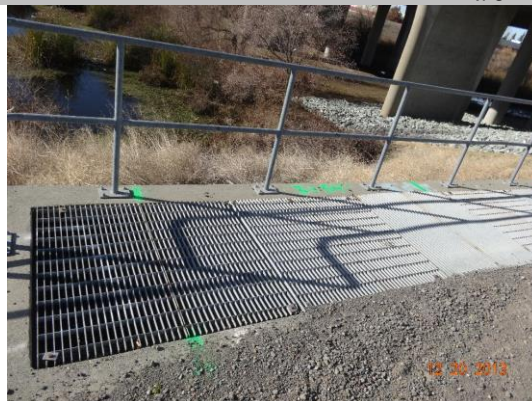
Photo 2 of 3 : UCIP\_SP\_2020\_49862\_52891.jpg

Concrete box contains 3-54 inch crossings.

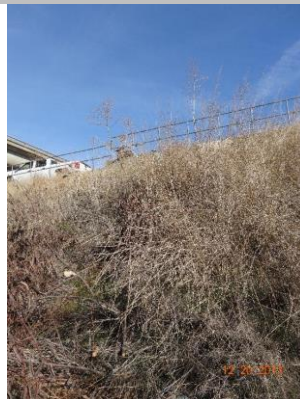
Photo 3 of 3 : UCIP\_SP\_2020\_49862\_52894.jpg

Dense vegetation located on waterward slope.

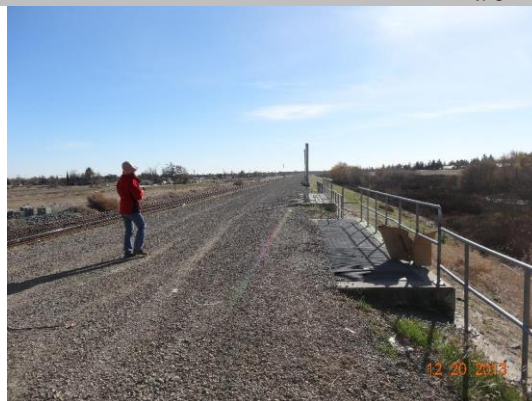
Photo 1 of 3 : UCIP\_SP\_2020\_49863\_52902.jpg

DS\_ID:24609  
FS\_ID:49863  
EP\_NO: 9596  
Repair Type: Non-Urgent  
Crossing Status: Indicator Found  
UCIP Comments: Dense vegetation on waterward side limits inspector's inspection--recommend removing vegetation to clear waterward slope.  
FIELD\_STRUCT\_DESC: [Sump No. 157] 2 of 3: 54-inch steel drainage pipe through the levee, 3 feet below the crown. Steel cutoff wall around pipe under center of levee. Siphon breaker in protective housing located on the waterside (WS) shoulder. Concrete headwall and flap gate located on the WS end. Trench on WS. Pumping plant located on the landside (LS). On March 28, 1995, the Sacramento City Council adopted Resolution No. 95-123 authorizing the execution of Agreement No. 95-065 regarding the transfer of drainage facilities that include Pump Station 7 as described by ARFCD and described by the City of Sacramento as Sump 157. (three 54-inch pipes installed in the siphon breaker structure but only one pipe installed through levee under Permit No. 9596, 9596-A, and 1975 - American River Flood Control District; second pipe installed through levee under Permit No. 9596-B, 1980 - American River Flood Control District; name change completed under Permit 9596-1 (includes work authorized under Permit No. 9596, 9596-A, and 9596-B), 2016 - City of Sacramento) [Additional Reference(s): DWR Levee Log, 2002]

Overview of levee crown with two concrete boxes with multiple crossings inside.

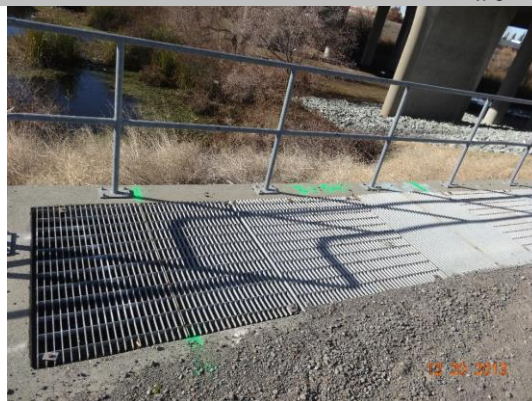
Photo 2 of 3 : UCIP\_SP\_2020\_49863\_52901.jpg

Concrete box contains 3-54 inch crossings.

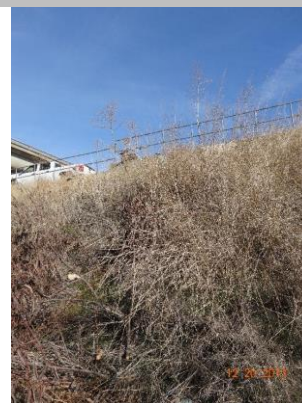
Photo 3 of 3 : UCIP\_SP\_2020\_49863\_52906.jpg

Dense vegetation located on waterward slope.

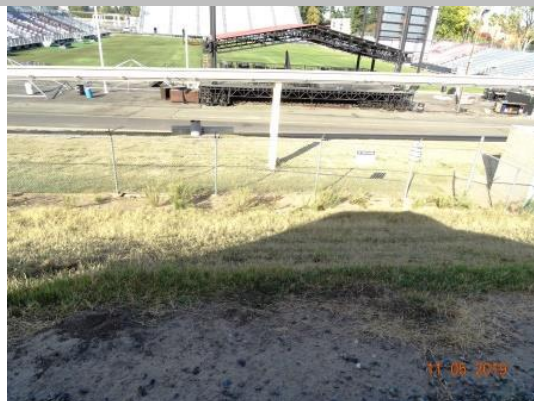
Photo 1 of 1 : SP\_2020\_NA0001\_490\_16\_20200302\_00004.jpg

LM Start	1.15	Rating **	A/W	Issue No.	16
LM End	1.15	Issue Type +	Ma	Location *	LS
Category	Earthen Levee			GPS Latitude/Longitude	
				Start	End
Item	Animal Control			38.590432 °	38.590432 °
				-121.438252 °	-121.438252 °
DWR ID	DWR_NA0001_03_f_2019_16				
Comment Code					
A3 : No rodents visible, but rodent burrows visible; need to backfill and compact or grout burrows.					
Inspector Comment

View of animal holes on the landside shoulder and slope. Fall 2019

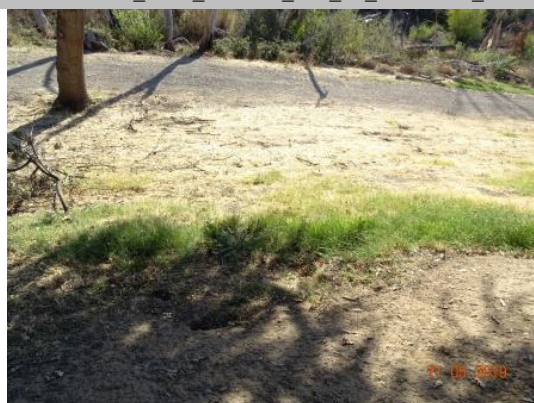
Photo 1 of 1 : SP\_2020\_NA0001\_490\_14\_20200302\_00002.jpg

LM Start	1.25	Rating **	A/W	Issue No.	14
LM End	1.25	Issue Type +	Ma	Location *	WS
Category	Earthen Levee			GPS Latitude/Longitude	
				Start	End
Item	Animal Control			38.590532 °	38.590532 °
				-121.440153 °	-121.440153 °
DWR ID	DWR_NA0001_03_f_2019_14				
Comment Code					
A3 : No rodents visible, but rodent burrows visible; need to backfill and compact or grout burrows.					
Inspector Comment

View of an animal hole on the levee slope. Fall 2019

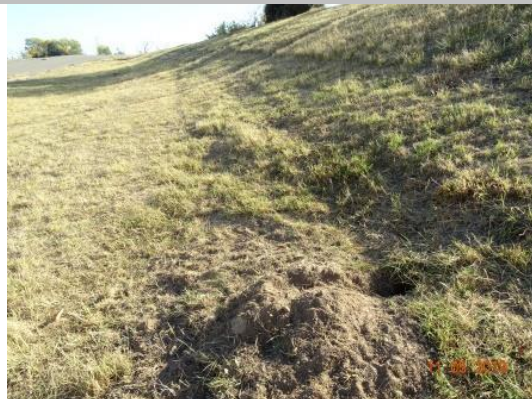
Photo 1 of 1 : SP\_2020\_NA0001\_490\_15\_20200302\_00003.jpg

LM Start	1.42	Rating **	A/W	Issue No.	15
LM End	1.42	Issue Type +	Ma	Location *	LS
Category	Earthen Levee			GPS Latitude/Longitude	
				Start	End
Item	Animal Control			38.592065 °	38.592065 °
				-121.442407 °	-121.442407 °
DWR ID	DWR_NA0001_03_f_2019_15				
Comment Code					
A3 : No rodents visible, but rodent burrows visible; need to backfill and compact or grout burrows.					
Inspector Comment					
LMA repaired animal holes.

View of animal holes on the landside slope. Fall 2019

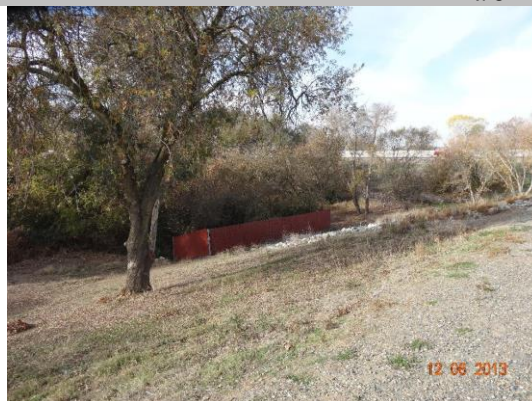
Photo 1 of 3 : UCIP\_SP\_2020\_50047\_53005.jpg

LM Start	1.53	Rating **	M	Issue No.	28	
LM End	1.53	Issue Type +	En	Location *		
Category	Supplemental			GPS Latitude/Longitude		
				Start	End	
Item	DWR UCIP Field Study			38.593054 °	38.593054 °	
				-121.444155 °	-121.444155 °	
DWR ID	24292

Comment Code						
Inspector Comment						
DS_ID:24292 FS_ID:50047 EP_NO: 5776 Repair Type: Non-Urgent Crossing Status: Found UCIP Comments: 8/11/2016 Issue has been addressed--no hole is present at site. Hole could have been associated with burrow activity. Need to contact owner to obtain internal integrity inspection to confirm pipe is in good condition. Crossing has been changed from Urgent to Non-Urgent due to limited evidence to support leak in pipe. (DWR UCIP - omagana)12/3/2013 Hole present next to concrete vault on levee crown (waterward side). Hole could be sink hole or burrow activity unable to determine. Need to contact owner to determine status of crossing and to investigate hole. (DWR UCIP - omagana) FIELD_STRUCT_DESC: [Drainage Plant No. 2] 5 of 6: 18-inch steel drainage pipe through the levee at an unknown depth below the crown. Metal cutoff wall around pipe under landside (LS) shoulder. Siphon breakers in concrete box located on the waterside (WS) shoulder. Pumping plant at LS toe. Access ramp to pumping plant located on LS. Concrete discharge box located on the WS. Flap gate located on the WS end. Outfall structure located on the WS. (Permit No. 5776, 1972 - American River Flood Control District; name change completed under Permit No. 5776-1, 2016 - City of Sacramento). [Additional Reference(s): DWR Levee Log, 2002]. FS Date: 8/11/2016

View of WS.

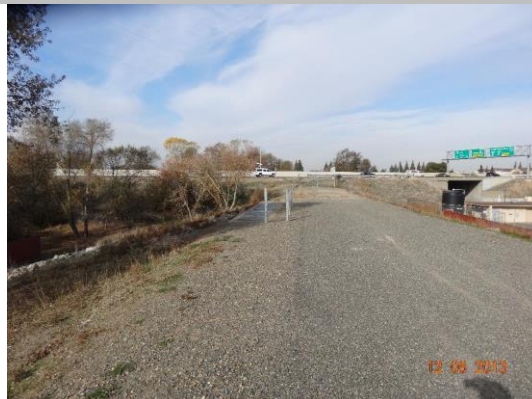
Photo 2 of 3 : UCIP\_SP\_2020\_50047\_53004.jpg

LM Start	<b>1.53</b>	Rating **	M	Issue No.	<b>28 (cont)</b>
LM End	<b>1.53</b>	Issue Type +	En	Location *	
Category	Supplemental		GPS Latitude/Longitude		
			Start	End	
Item	DWR UCIP Field Study		38.593054 °	38.593054 °	
			-121.444155 °	-121.444155 °	
DWR ID	24292

View of levee crown--concrete vault located on WS shoulder.

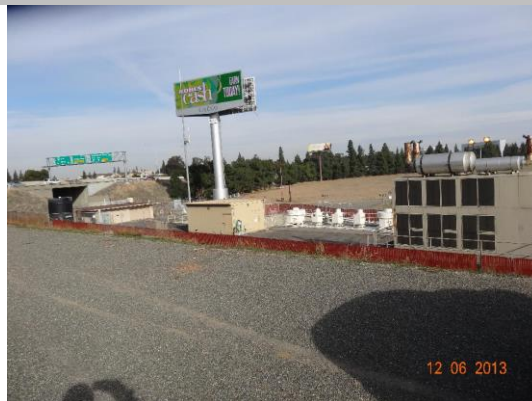
Photo 3 of 3 : UCIP\_SP\_2020\_50047\_53003.jpg

LM Start	<b>1.53</b>	Rating **	M	Issue No.	<b>28 (cont)</b>
LM End	<b>1.53</b>	Issue Type +	En	Location *

View of LS.

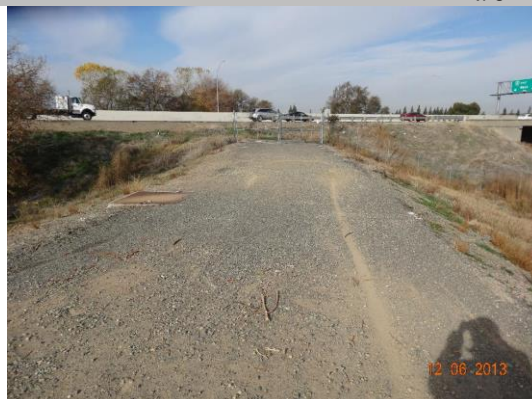
Photo 1 of 3 : UCIP\_SP\_2020\_31224\_57130.jpg

LM Start	1.54	Rating **	M	Issue No.	29
LM End	1.54	Issue Type +	En	Location *	
Category	Supplemental			GPS Latitude/Longitude	
				Start	End
Item	DWR UCIP Field Study			38.593290 °	38.593290 °
				-121.443980 °	-121.443980 °
DWR ID	24644				
Comment Code					
Inspector Comment					
DS_ID:24644 FS_ID:31224 EP_NO: 2805 Repair Type: Non-Urgent Crossing Status: Indicator Found UCIP Comments: Unable to confirm what crossings are going through levee. Will need to coordinate iwth owner to determine active crossings. FIELD_STRUCT_DESC: [Arden Treatment Plant] 3 of 4: 34-inch concrete encased sewer pipe through the levee, 7.5 feet below the crown. Concrete cutoff wall around pipe under center of levee. Siphon breaker in housing at waterside (WS) shoulder. Treatment plant on landside (LS). [Additional Reference(s): DWR Levee Log, 2002] FS Date: 12/3/2013

View of levee crown and concrete box located on waterward shoulder.

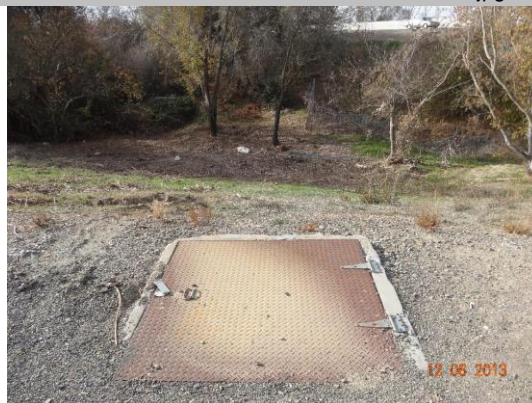
Photo 2 of 3 : UCIP\_SP\_2020\_31224\_57129.jpg

LM Start	<b>1.54</b>	Rating **	M	Issue No.	<b>29 (cont)</b>
LM End	<b>1.54</b>	Issue Type +	En	Location *

Concrete box located on waterward shoulder.

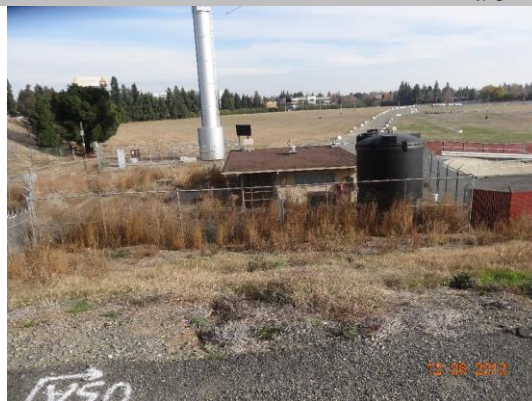
Photo 3 of 3 : UCIP\_SP\_2020\_31224\_57128.jpg

LM Start	<b>1.54</b>	Rating **	M	Issue No.	<b>29 (cont)</b>
LM End	<b>1.54</b>	Issue Type +	En	Location *	
Category	Supplemental		GPS Latitude/Longitude		
			Start	End	
Item	DWR UCIP Field Study		38.593290 °	38.593290 °	
			-121.443980 °	-121.443980 °	
DWR ID	24644

View of landward side.

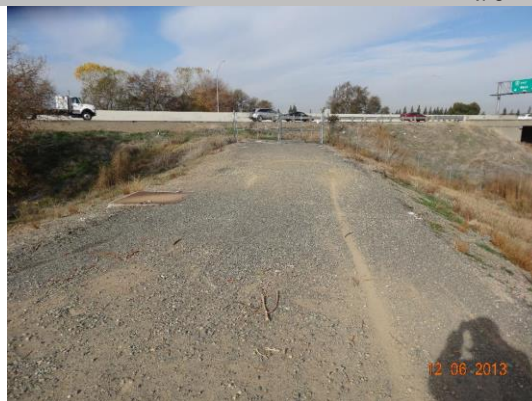
Photo 1 of 3 : UCIP\_SP\_2020\_31225\_57135.jpg

LM Start	<b>1.54</b>	Rating **	M	Issue No.	<b>30</b>
LM End	<b>1.54</b>	Issue Type +	En	Location *	
Category	Supplemental		GPS Latitude/Longitude		
			Start	End	
Item	DWR UCIP Field Study		38.593290 °	38.593290 °	
			-121.443980 °	-121.443980 °	
DWR ID	24645

DS\_ID:24645  
 FS\_ID:31225  
 EP\_NO: 2805  
 Repair Type: Non-Urgent  
 Crossing Status: Indicator Found  
 UCIP Comments: Unable to confirm what crossings are going through levee. Will need to coordinate with owner to determine active crossings.  
 FIELD\_STRUCT\_DESC: [Arden Treatment Plant] 4 of 4: 34-inch concrete encased sewer pipe through the levee, 6.2 feet below the crown. Concrete cutoff wall around pipe under center of levee. Siphon breaker in housing at waterside (WS) shoulder. Treatment plant on landside (LS). [Additional Reference(s): DWR Levee Log, 2002]  
 FS Date: 12/3/2013

View of levee crown and concrete box located on waterward shoulder.

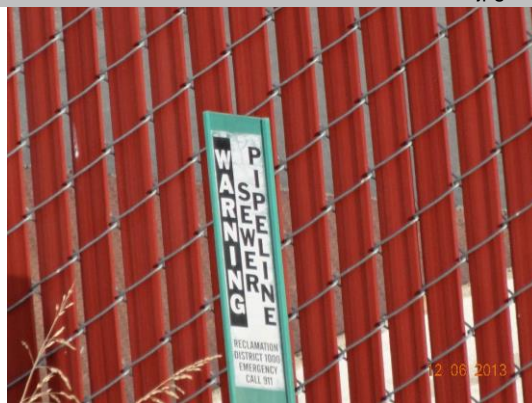
Photo 3 of 3 : UCIP\_SP\_2020\_31225\_57132.jpg

LM Start	<b>1.54</b>	Rating **	M	Issue No.	<b>30 (cont)</b>
LM End	<b>1.54</b>	Issue Type +	En	Location *

Sewer marker visible on landward toe.

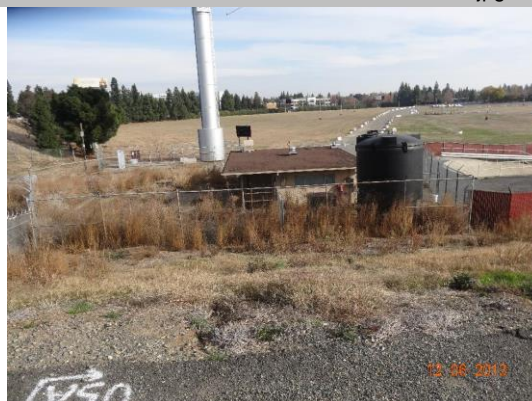
Photo 2 of 3 : UCIP\_SP\_2020\_31227\_57138.jpg

Comment Code						
Inspector Comment						
DS_ID:24293 FS_ID:31227 EP_NO: 2805 Repair Type: Non-Urgent Crossing Status: Indicator Found UCIP Comments: Will need to coordinate with the owner to determine the status of the crossings. FIELD_STRUCT_DESC: [Sacramento County Sanitation District No. 2 Pump Station] 18-inch concrete sewer main through the levee, 6 feet below the crown, 2 feet below slopes, and 4 feet along channel bottom. Concrete cutoff wall around the pipe under the center of the levee. 2-inch air release valve located on the waterside (WS) shoulder of the north levee. Treatment plant on the landside (LS). Crossing continues under the channel and through the opposite levee. (18-inch pipe authorized under Permit No. 2805, 1958 - Sacramento County Sanitation District No. 2). FS Date: 12/3/2013

View of landward side.

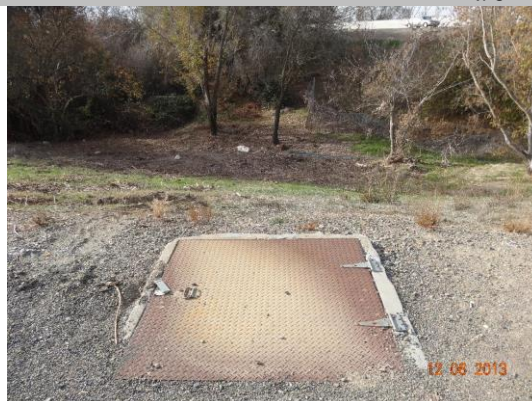
Photo 2 of 3 : UCIP\_SP\_2020\_31223\_57123.jpg

LM Start	<b>1.55</b>	Rating **	M	Issue No.	<b>32 (cont)</b>
LM End	<b>1.55</b>	Issue Type +	En	Location *	
Category	Supplemental		GPS Latitude/Longitude		
			Start	End	
Item	DWR UCIP Field Study		38.593224 °	38.593224 °	
			-121.444299 °	-121.444299 °	
DWR ID	24643

Concrete box located on waterward shoulder.

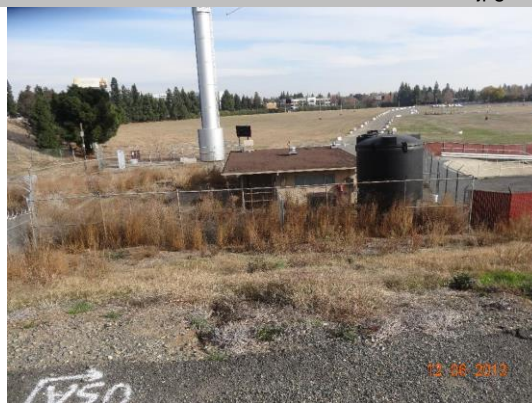
Photo 3 of 3 : UCIP\_SP\_2020\_31223\_57122.jpg

LM Start	<b>1.55</b>	Rating **	M	Issue No.	<b>32 (cont)</b>
LM End	<b>1.55</b>	Issue Type +	En	Location *

View of landward side.

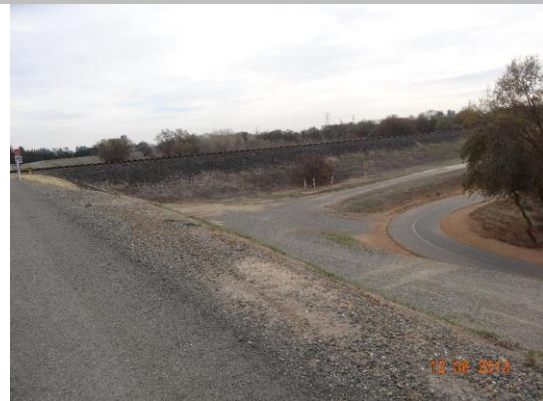
Photo 1 of 3 : UCIP\_SP\_2020\_31230\_57146.jpg

LM Start	1.91	Rating **	M	Issue No.	33	
LM End	1.91	Issue Type +	En	Location *		
Category	Supplemental			GPS Latitude/Longitude		
				Start	End	
Item	DWR UCIP Field Study			38.596096 °	38.596096 °	
				-121.449815 °	-121.449815 °	
DWR ID	24801					
Comment Code						
Inspector Comment						
DS_ID:24801						
FS_ID:31230						
EP_NO: N/A						
Repair Type: Non-Urgent						
Crossing Status: Found						
UCIP Comments: No permit found--need to contact owner to determine status of crossing.						
FIELD_STRUCT_DESC: Gas line through levee at unknown depth.						
Markers visible on waterside (WS) and landside (LS). Kinder Morgan contacts' information is 916-363-1666.						
FS Date: 12/6/2013

View of waterward side.

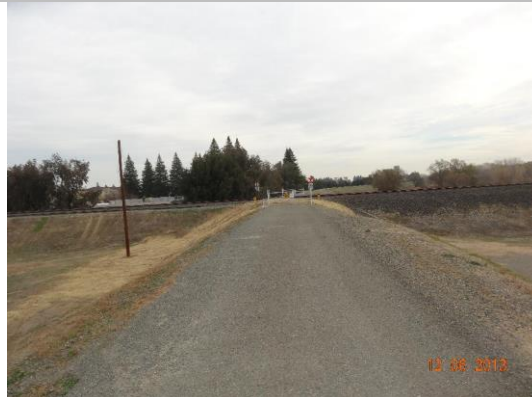
Photo 2 of 3 : UCIP\_SP\_2020\_31230\_57145.jpg

LM Start	<b>1.91</b>	Rating **	M	Issue No.	<b>33 (cont)</b>
LM End	<b>1.91</b>	Issue Type +	En	Location *	
Category	Supplemental		GPS Latitude/Longitude		
			Start	End	
Item	DWR UCIP Field Study		38.596096 °	38.596096 °	
			-121.449815 °	-121.449815 °	
DWR ID	24801

Overview of levee crown at crossing.

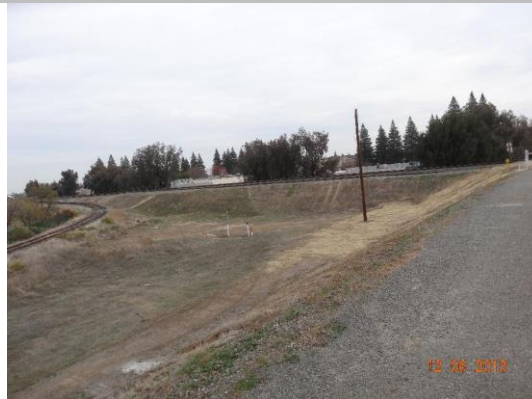
Photo 3 of 3 : UCIP\_SP\_2020\_31230\_57144.jpg

LM Start	<b>1.91</b>	Rating **	M	Issue No.	<b>33 (cont)</b>
LM End	<b>1.91</b>	Issue Type +	En	Location *

View of landward side.

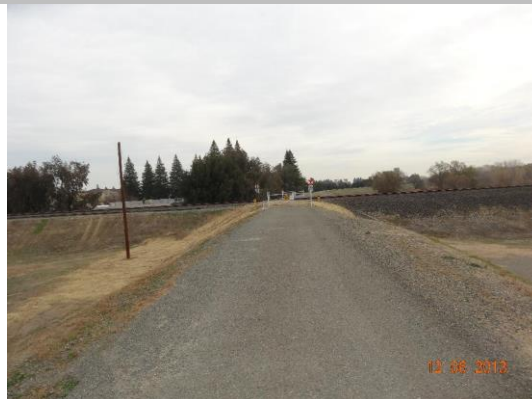
Photo 1 of 3 : UCIP\_SP\_2020\_29826\_55135.jpg

LM Start	1.91	Rating **	M	Issue No.	34
LM End	1.91	Issue Type +	En	Location *	
Category	Supplemental			GPS Latitude/Longitude	
				Start	End
Item	DWR UCIP Field Study			38.596108 °	38.596108 °
				-121.449887 °	-121.449887 °
DWR ID	24294				
Comment Code					
Inspector Comment					
DS_ID:24294					
FS_ID:29826					
EP_NO: N/A					
Repair Type: Non-Urgent					
Crossing Status: Indicator Found					
UCIP Comments: Unable to confirm the diameter size or which owner is responsible for crossing. Owner could be Quest Communication or MCI--Need to contact owner to confirm crossing and obtain encroachment permit for work.					
FIELD_STRUCT_DESC: Communications conduit through the levee at unknown depth. [Additional Reference(s): DWR Levee Log, 2002]					
FS Date: 12/6/2013

Overview of levee crown looking upstram at crossing.

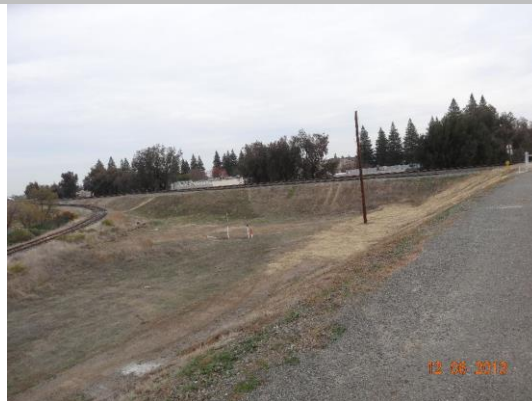
Photo 2 of 3 : UCIP\_SP\_2020\_29826\_55134.jpg

LM Start	<b>1.91</b>	Rating **	M	Issue No.	<b>34 (cont)</b>
LM End	<b>1.91</b>	Issue Type +	En	Location *

View of landward side--conduit markers visible.

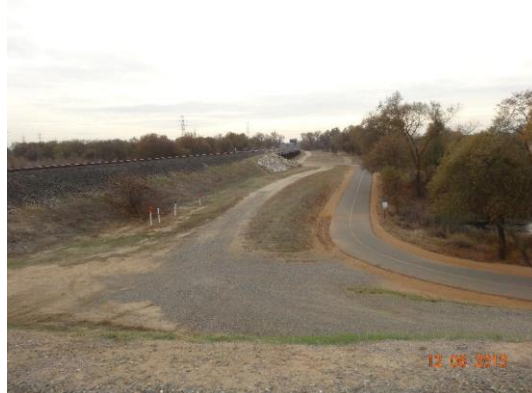
Photo 3 of 3 : UCIP\_SP\_2020\_29826\_55133.jpg

LM Start	<b>1.91</b>	Rating **	M	Issue No.	<b>34 (cont)</b>
LM End	<b>1.91</b>	Issue Type +	En	Location *	
Category	Supplemental		GPS Latitude/Longitude		
			Start	End	
Item	DWR UCIP Field Study		38.596108 °	38.596108 °	
			-121.449887 °	-121.449887 °	
DWR ID	24294

View of waterward side--markers visible.

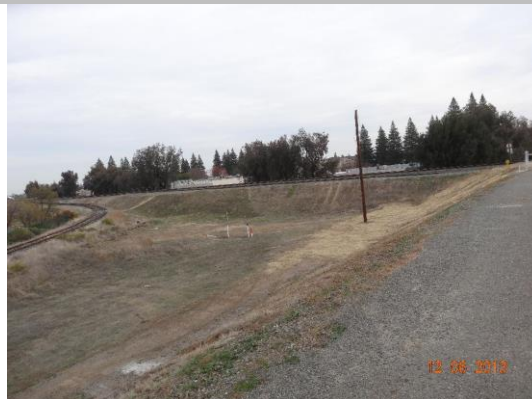
Photo 2 of 3 : UCIP\_SP\_2020\_29827\_55140.jpg

DS\_ID:24296  
 FS\_ID:29827  
 EP\_NO: N/A  
 Repair Type: Non-Urgent  
 Crossing Status: Indicator Found  
 UCIP Comments: Unable to confirm the diameter size or which owner is responsible for crossing. Owner could be Quest Communication or MCI--Need to contact owner to confirm crossing and obtain encroachment permit for work.  
 FIELD\_STRUCT\_DESC: 3-inch cable through the levee, 2.5 feet below the crown. Two overhead telephone lines across the levee at location.  
 [Additional Reference(s): DWR Levee Log, 2002]  
 FS Date: 12/6/2013

LM Start	<b>1.92</b>	Rating **	M	Issue No.	<b>35 (cont)</b>
LM End	<b>1.92</b>	Issue Type +	En	Location *	
Category	Supplemental		GPS Latitude/Longitude		
			Start	End	
Item	DWR UCIP Field Study		38.596108 °	38.596108 °	
			-121.449887 °	-121.449887 °	
DWR ID	24296

Conduit markers visible on landward side.

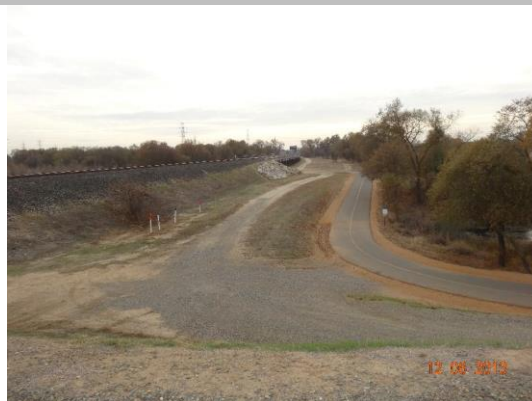
Photo 3 of 3 : UCIP\_SP\_2020\_29827\_55139.jpg

LM Start	<b>1.92</b>	Rating **	M	Issue No.	<b>35 (cont)</b>
LM End	<b>1.92</b>	Issue Type +	En	Location *

Conduit markers visible on waterward side.

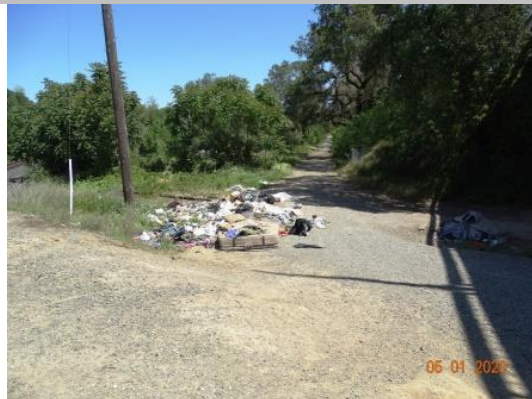
Photo 1 of 1 : SP\_2020\_NA0001\_490\_26\_20200508\_00033.jpg

LM Start	3.19	Rating **	M	Issue No.	26
LM End	3.19	Issue Type +	Ma	Location *	LS
Category	Earthen Levee			GPS Latitude/Longitude	
				Start	End
Item	Encroachments			38.599442 °	38.599442 °
				-121.470435 °	-121.470435 °
DWR ID	DWR_NA0001_03_s_2020_26				
Comment Code					
DE : Debris					
Inspector Comment					
Remove debris from the landside toe.

View of debris on the landside toe. Spring 2020

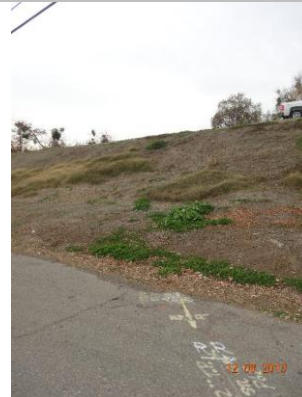
Photo 1 of 3 : UCIP\_SP\_2020\_52686\_53391.jpg

Comment Code					
Inspector Comment					
DS_ID:24648 FS_ID:52686 EP_NO: 911 Repair Type: Non-Urgent Crossing Status: Found UCIP Comments: 08/11/2017 PG&E records for DFM 0613-01 indicate that there were no observations found on the 07/2017 patrol, no leaks found on the 05/2017 leak survey, and the pipeline is operating correctly according to the 04/2017 CP inspection. ECDA in 2015; this integrity assessment identified no issues requiring corrective action. ILI in 2016; all corrective actions identified in this integrity assessment have been resolved. (DWR UCIP - A. McDonald)8/11/2016 Markers found on WS. No markers found on LS. Crossing has been downgraded from Urgent to Non-Urgent, pipe has been marked on WS only. (DWR UCIP - omagana)2/6/2015 Permit information was entered and crossing description updated. (DWR UCIP - omagana)12/3/13 Need to contact owner to determine status of crossing. Markers missing. (DWR UCIP - omagana) FIELD_STRUCT_DESC: 12.75-inch gas line of unknown material through the levee at unknown depth. Markers found on the waterside (WS) approximately 192 feet and 410 feet from levee crown. No markers found on landside (LS). In case of an emergency related to this pipeline, PG&E has identified the following contacts: PG&E's local pipeline engineer, Mike Aronoff at 916-307-9472 (cell), and Gas Control (north) at 800-442-4743. For non-emergency issues, please contact the local PG&E Gas Pipeline Operations and Maintenance (GPOM) supervisors for the Sacramento region, David Wade at 209-639-1039 (cell), or Ron Hicks at 916-396-9038 (cell). (12.75-inch line installed under Permit No. 911, 1943 - Pacific Gas and Electric Company [PG&E]) FS Date: 8/11/2016

View of LS slope and USA paint markings indicating alignment.

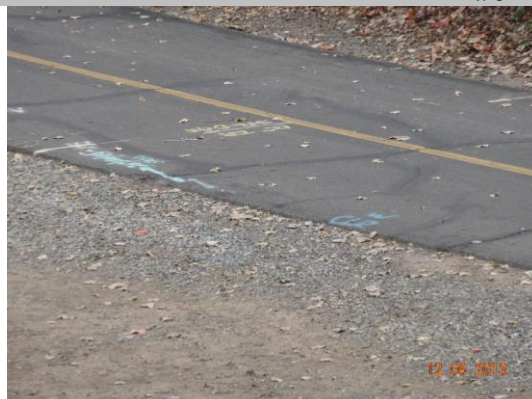
Photo 2 of 3 : UCIP\_SP\_2020\_52686\_53390.jpg

LM Start	<b>3.29</b>	Rating **	M	Issue No.	<b>36 (cont)</b>
LM End	<b>3.29</b>	Issue Type +	En	Location *	
Category	Supplemental		GPS Latitude/Longitude		
			Start	End	
Item	DWR UCIP Field Study		38.600718 °	38.600718 °	
			-121.471491 °	-121.471491 °	
DWR ID	24648

Underground service alert (USA) approximate alignment for 12-inch gas line through levee and WS-USA markings on bike path.

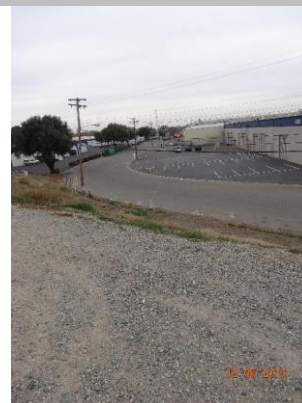
Photo 3 of 3 : UCIP\_SP\_2020\_52686\_53389.jpg

View of LS with undergroundservice alert (USA) paint with approximate alignment of multiple crossing in general area.

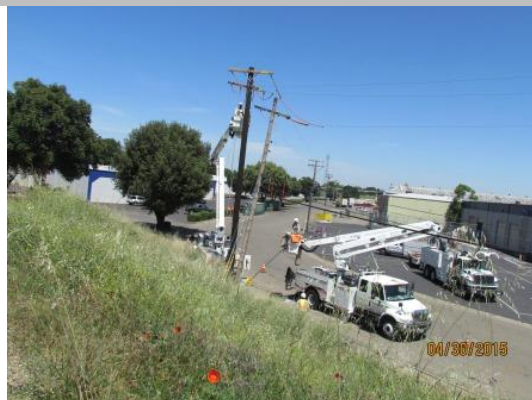
Photo 1 of 1 : SP\_2020\_NA0001\_490\_24\_20200302\_00005.jpg

LM Start	3.31	Rating **	M	Issue No.	24
LM End	3.31	Issue Type +	En	Location *	LS
Category	Earthen Levee			GPS Latitude/Longitude	
				Start	End
Item	Encroachments			38.600958 °	38.600958 °
				-121.471618 °	-121.471618 °
DWR ID	DWR_NA0001_03_s_2015_24				
Comment Code					
PO : Pole					
Inspector Comment					
A utility pole line does not appear to be permitted.

View of a pole installed at the landside levee toe. Spring 2015

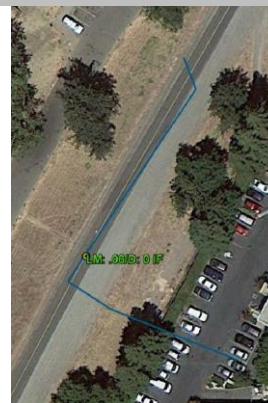
Photo 1 of 3 : UCIP\_SP\_2020\_29003\_53405.jpg

LM Start	0.06	Rating **	M	Issue No.	746
LM End	0.06	Issue Type +	En	Location *	
Category	Supplemental			GPS Latitude/Longitude	
				Start	End
Item	DWR UCIP Field Study			38.597198 °	38.597198 °
				-121.506532 °	-121.506532 °
DWR ID	24344				
Comment Code					
Inspector Comment					
DS_ID:24344 FS_ID:29003 EP_NO: N/A Repair Type: Non-Urgent Crossing Status: Indicator Found UCIP Comments: Metal boxes located on landward side could be associated with utility -- unable to confirm. Will need to contact owner. FIELD_STRUCT_DESC: Electrical conduit of unknown material through the levee at unknown depth. FS Date: 12/19/2013

Approximate alignment provided by the City of Sacramento for 2 inch line. Point labelled in green is field verified location where signs of crossing exist.

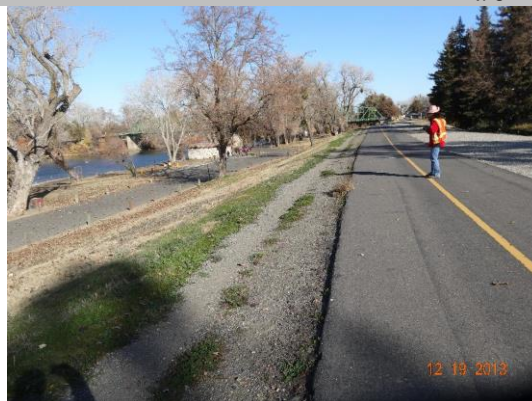
Photo 2 of 3 : UCIP\_SP\_2020\_29003\_53404.jpg

Overview of levee crown and waterward side.

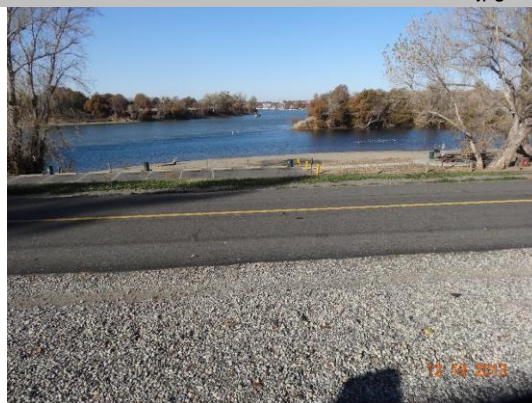
Photo 3 of 3 : UCIP\_SP\_2020\_29003\_53402.jpg

View of waterward side.

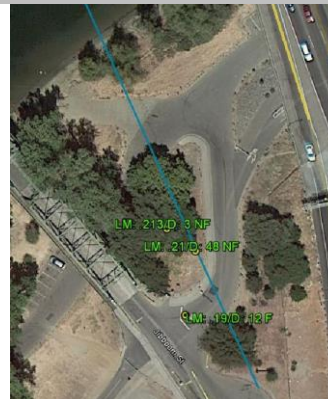
Photo 1 of 1 : UCIP\_SP\_2020\_29006\_53414.jpg

LM Start	0.21	Rating **	M	Issue No.	747	
LM End	0.21	Issue Type +	En	Location *		
Category	Supplemental			GPS Latitude/Longitude		
				Start		End
Item	DWR UCIP Field Study			38.598982 °		38.598982 °
				-121.505045 °		-121.505045 °
DWR ID	24435					
Comment Code						
Inspector Comment						
DS_ID:24435						
FS_ID:29006						
EP_NO: 17171						
Repair Type: Non-Urgent						
Crossing Status: Not Found						
UCIP Comments: Unable to find any indications that crossing is still active. Will need to contact owner to determine status of crossing.						
FIELD_STRUCT_DESC: 48-inch steel water line through the levee, approximately 32 feet below the crown. Siphon and blowoff valves in concrete riser on the landside (LS). (48-inch water transmission main authorized under Permit No. 17171, 2001-City of Sacramento, Department of Utilities)						
FS Date: 12/19/2013

Approximate alignment provided by the City of Sacramento--crossing not found during field visit.

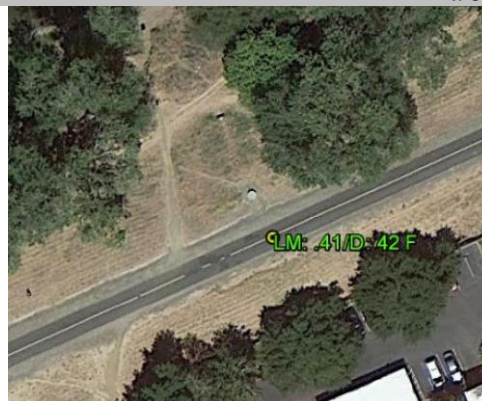
Photo 1 of 3 : UCIP\_SP\_2020\_31249\_57212.jpg

DS\_ID:24303  
FS\_ID:31249  
EP\_NO: N/A  
Repair Type: Non-Urgent  
Crossing Status: Found  
UCIP Comments: 08/16/2017 DWR Deferred Maintenance Project (DMP), Vince Rodriguez, forwarded email received from Tim Kerr, General Manager of American River Flood Control District (ARFCD) with file "DWR Eligible Pipes Found in ARFCD" from ARFCD that shows the ownership and location of the pipes Tim Kerr investigated. No owner was identified, ARFCD Staff Notes indicate Abandoned (ARFCD/Bill) - No As-builts. (DWR UCIP - O. Magana)  
12/19/2013 Non-functional crossing--need additional information about how crossing was abandoned. (DWR UCIP - O. Magana)  
FIELD\_STRUCT\_DESC: \*ABANDONED\* 42-inch corrugated metal drainage pipe through the levee, 16.5 feet below the crown. Gravel filled with both ends welded shut. Flap gate on the waterside (WS) end. Slide gate in corrugated metal riser and splash board drain structure on the landside (LS). (no permit has been identified authorizing this structure, no owner has been identified) [Additional Reference(s): DWR Levee Log, 2002. USACE Sacramento O&M Manual Unit 118 Part 1, August 1955, (Station 10+00)].

Overview of crossing location.

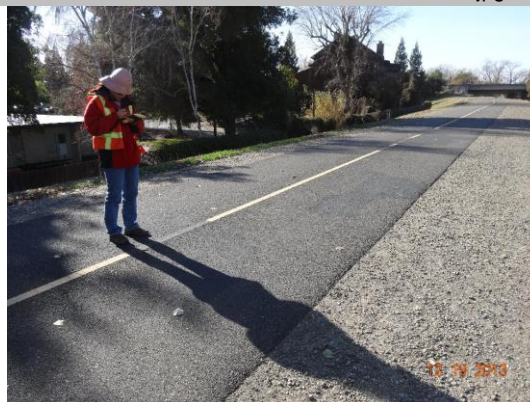
Photo 2 of 3 : UCIP\_SP\_2020\_31249\_57209.jpg

View of levee crown at this location.

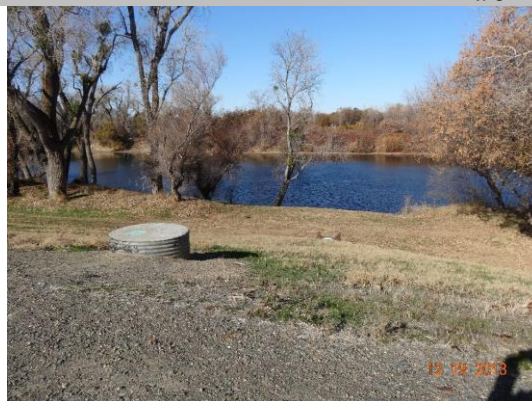
Photo 3 of 3 : UCIP\_SP\_2020\_31249\_57210.jpg

View of waterward side--standpipe located on waterward slope.  
Standpipe filled with concrete.

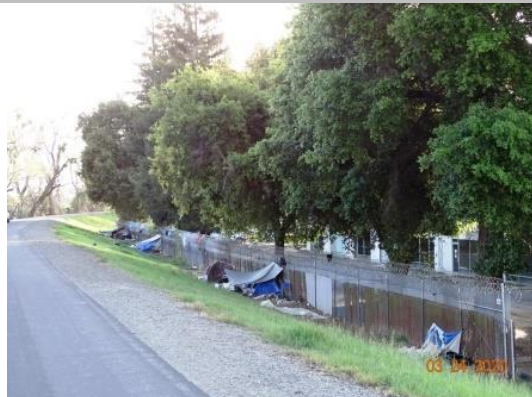
Photo 1 of 1 : SP\_2020\_NA0001\_55\_164\_20200427\_00261.jpg

LM Start	0.47	Rating **	M	Issue No.	164
LM End	0.47	Issue Type +	En	Location *	LS
Category	Earthen Levee			GPS Latitude/Longitude	
				Start	End
Item	Encroachments			38.600873 °	38.600873 °
				-121.500817 °	-121.500817 °
DWR ID	DWR_NA0001_04_s_2020_164				
Comment Code					
EQ : Equipment					
Inspector Comment					
Tents are placed along the landside toe.

View of tents along the landside toe. Spring 2020

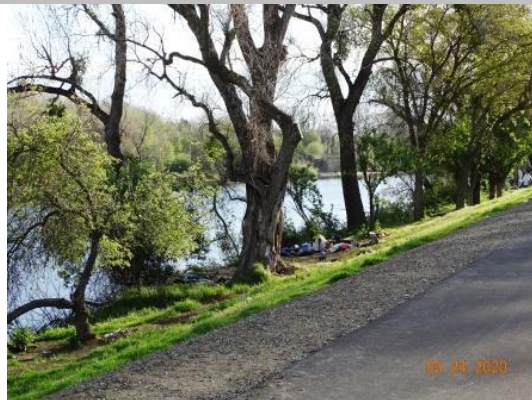
Photo 1 of 1 : SP\_2020\_NA0001\_55\_174\_20200427\_00262.jpg

LM Start	0.65	Rating **	M	Issue No.	174
LM End	0.68	Issue Type +	En	Location *	WS
Category	Earthen Levee			GPS Latitude/Longitude	
				Start	End
Item	Encroachments			38.601443 °	38.601553 °
				-121.497703 °	-121.497172 °
DWR ID	DWR_NA0001_04_s_2020_174				
Comment Code					
DE : Debris					
Inspector Comment

View of camping debris on the waterside slope. Spring 2020

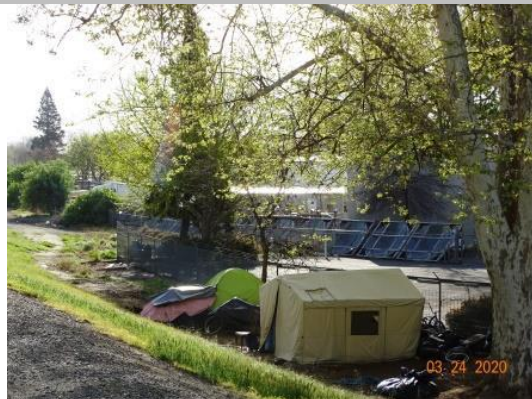
Photo 1 of 1 : SP\_2020\_NA0001\_55\_186\_20200427\_00263.jpg

LM Start	0.69	Rating **	M	Issue No.	186
LM End	0.69	Issue Type +	En	Location *	LS
Category	Earthen Levee			GPS Latitude/Longitude	
				Start	End
Item	Encroachments			38.601550 °	38.601550 °
				-121.496963 °	-121.496963 °
DWR ID	DWR_NA0001_04_s_2020_186				
Comment Code					
EQ : Equipment					
Inspector Comment					
Tents are set up on the landside toe.

View of camping equipment at the landside toe. Spring 2020

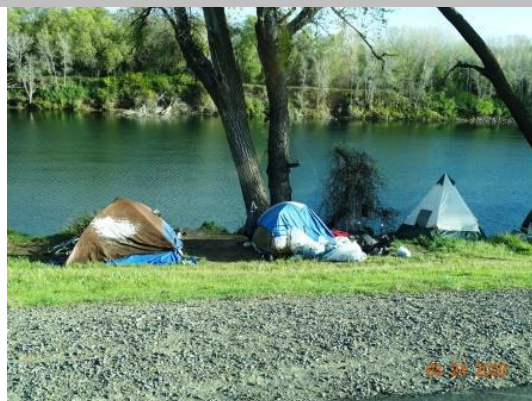
Photo 1 of 1 : SP\_2020\_NA0001\_55\_197\_20200427\_00264.jpg

LM Start	0.73	Rating **	M	Issue No.	197
LM End	0.73	Issue Type +	En	Location *	WS
Category	Earthen Levee			GPS Latitude/Longitude	
				Start	End
Item	Encroachments			38.601595 °	38.601595 °
				-121.496263 °	-121.496263 °
DWR ID	DWR_NA0001_04_s_2020_197				
Comment Code					
EQ : Equipment					
Inspector Comment					
Tents are set up on the waterside toe.

View of tents at the waterside toe. Spring 2020

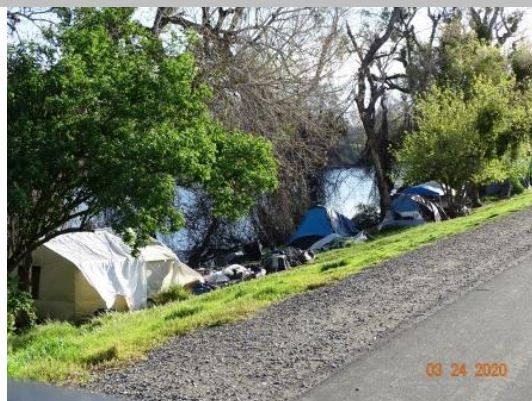
Photo 1 of 1 : SP\_2020\_NA0001\_55\_218\_20200427\_00266.jpg

LM Start	0.80	Rating **	M	Issue No.	218
LM End	0.87	Issue Type +	En	Location *	WS
Category	Earthen Levee			GPS Latitude/Longitude	
				Start	End
Item	Encroachments			38.601685 °	38.601673 °
				-121.494820 °	-121.493590 °
DWR ID	DWR_NA0001_04_s_2020_218				
Comment Code					
EQ : Equipment					
Inspector Comment					
Campers reside at the waterside toe.

View of tents at the waterside toe. Spring 2020

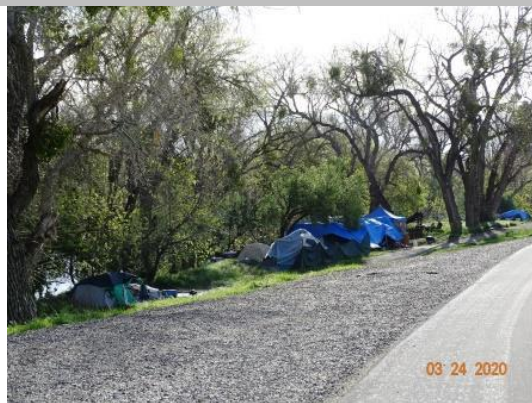
Photo 1 of 1 : SP\_2020\_NA0001\_55\_248\_20200427\_00268.jpg

LM Start	1.44	Rating **	M	Issue No.	248
LM End	1.47	Issue Type +	En	Location *	WS
Category	Earthen Levee			GPS Latitude/Longitude	
				Start	End
Item	Encroachments			38.600005 °	38.599763 °
				-121.483317 °	-121.482822 °
DWR ID	DWR_NA0001_04_s_2020_248				
Comment Code					
EQ : Equipment					
Inspector Comment					
Campers reside on the waterside toe.

View of tents at the waterside toe. Spring 2020

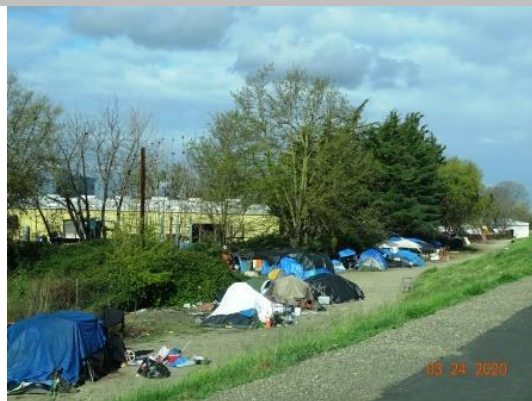
Photo 1 of 1 : SP\_2020\_NA0001\_55\_255\_20200427\_00271.jpg

LM Start	1.62	Rating **	M	Issue No.	255
LM End	1.70	Issue Type +	En	Location *	LS
Category	Earthen Levee			GPS Latitude/Longitude	
				Start	End
Item	Encroachments			38.598825 °	38.598122 °
				-121.480370 °	-121.479263 °
DWR ID	DWR_NA0001_04_s_2020_255				
Comment Code					
EQ : Equipment					
Inspector Comment					
Campers reside within 10' of the landside toe.

View of tents at the landside toe. Spring 2020

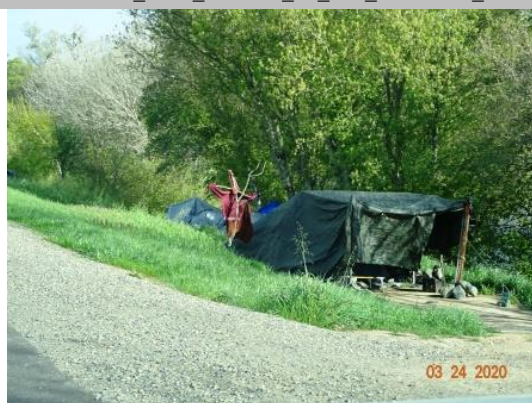
Photo 1 of 1 : SP\_2020\_NA0001\_55\_256\_20200427\_00269.jpg

LM Start	1.75	Rating **	M	Issue No.	256
LM End	1.76	Issue Type +	En	Location *	WS
Category	Earthen Levee			GPS Latitude/Longitude	
				Start	End
Item	Encroachments			38.597525 °	38.597378 °
				-121.478802 °	-121.478650 °
DWR ID	DWR_NA0001_04_s_2020_256				
Comment Code					
EQ : Equipment					
Inspector Comment					
Campers reside on the waterside ramp.

View of tents on the waterside ramp. Spring 2020

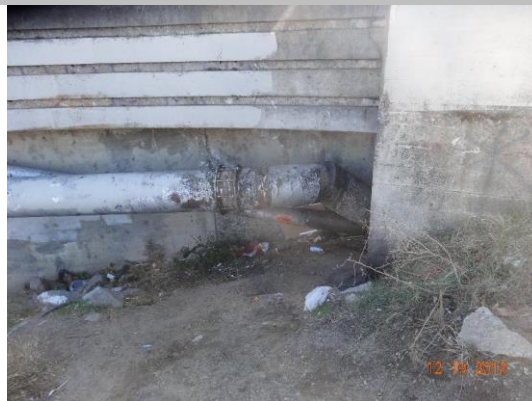
Photo 2 of 3 : UCIP\_SP\_2020\_53602\_53495.jpg

Two crossings visible at bridge.

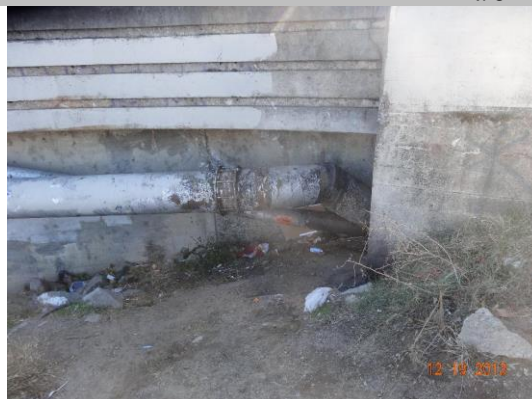
Photo 2 of 3 : UCIP\_SP\_2020\_52685\_55421.jpg

Larger line is not marked as gas line and smaller line has label indicating gas line.

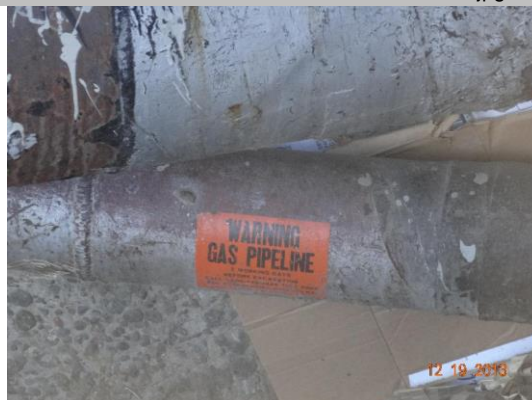
Photo 3 of 3 : UCIP\_SP\_2020\_52685\_55420.jpg

Label found on smaller pipe at bridge.

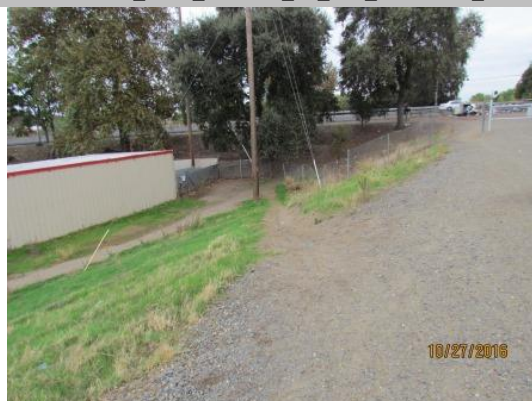
Photo 1 of 1 : SP\_2020\_NA0001\_55\_244\_20200302\_00187.jpg

LM Start	1.95	Rating **	A/W	Issue No.	244
LM End	1.95	Issue Type +	Ma	Location *	LS
Category	Earthen Levee			GPS Latitude/Longitude	
				Start	End
Item	Slope Stability			38.595040 °	38.595040 °
				-121.476882 °	-121.476882 °
DWR ID	DWR_NA0001_04_f_2015_244				
Comment Code					
S1 : Repair slope instability.					
Inspector Comment					
The erosion of the levee slope from the footpath appears to be stable at this time and should be monitored.

View of the footpath on the landside levee slope. Fall 2016

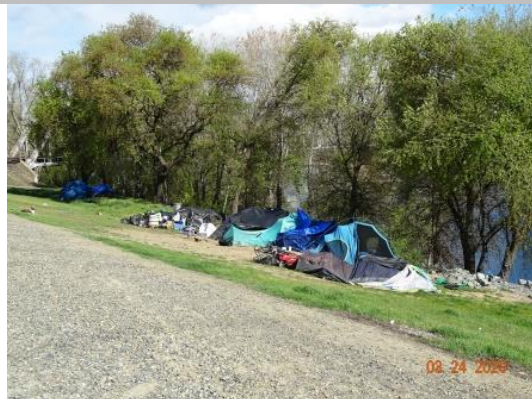
Photo 1 of 1 : SP\_2020\_NA0001\_55\_277\_20200427\_00273.jpg

LM Start	2.24	Rating **	M	Issue No.	277
LM End	2.28	Issue Type +	En	Location *	WS
Category	Earthen Levee			GPS Latitude/Longitude	
				Start	End
Item	Encroachments			38.592063 °	38.591572 °
				-121.473632 °	-121.473188 °
DWR ID	DWR_NA0001_04_s_2020_277				
Comment Code					
EQ : Equipment					
Inspector Comment					
Campers reside at the waterside toe.

View of tents at the waterside toe. Spring 2020

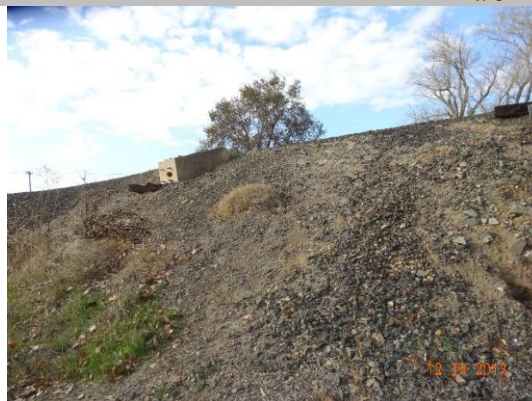
Photo 1 of 3 : UCIP\_SP\_2020\_29927\_55259.jpg

LM Start	2.25	Rating **	M	Issue No.	751
LM End	2.25	Issue Type +	En	Location *	
Category	Supplemental			GPS Latitude/Longitude	
				Start	End
Item	DWR UCIP Field Study			38.591923 °	38.591923 °
				-121.473744 °	-121.473744 °
DWR ID	24310				
Comment Code					
Inspector Comment					
DS_ID:24310 FS_ID:29927 EP_NO: 14150 Repair Type: Non-Urgent Crossing Status: Indicator Found UCIP Comments: unable to confirm if crossing is 4-inch steel conduit--will need to coordinate with owner. FIELD_STRUCT_DESC: 4-inch galvanized iron communication conduit containing fiber optic cables through the levee, 3.5 feet below the crown. Markers on the levee shoulder. Rock revetment on the waterside (WS) slope. (4-inch galvanized iron pipe authorized under Permit No. 14150, 1986-MCI Telecommunication Corp.) [Additional Reference(s): DWR Levee Log, 2002] FS Date: 12/19/2013

View of waterward slope--concrete box could be associated with conduit?

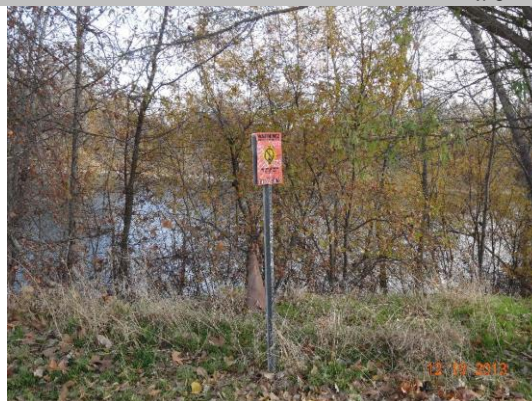
Photo 2 of 3 : UCIP\_SP\_2020\_29927\_55261.jpg

Marker for buried fiber optic cable on waterward side.

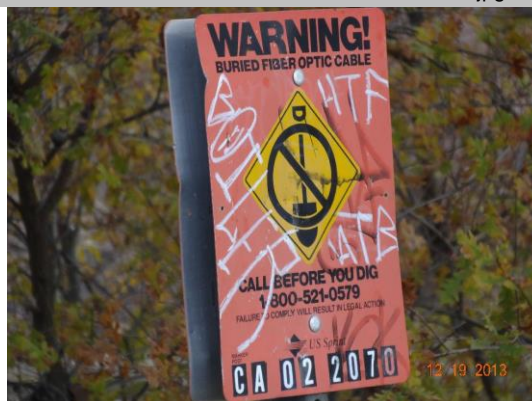
Photo 3 of 3 : UCIP\_SP\_2020\_29927\_55260.jpg

Contact information for US Sprint--not MCI as records indicate.

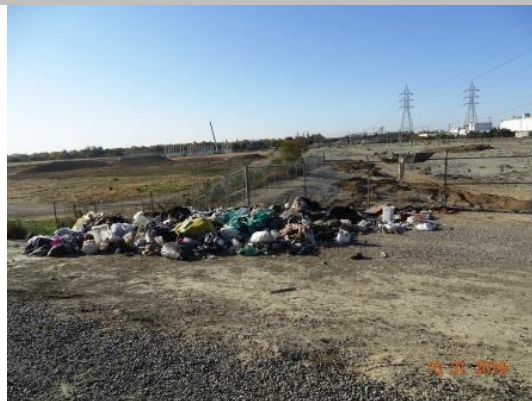
Photo 1 of 1 : SP\_2020\_NA0001\_55\_236\_20200302\_00185.jpg

LM Start	2.35	Rating **	M	Issue No.	236
LM End	2.35	Issue Type +	En	Location *	LS
Category	Earthen Levee			GPS Latitude/Longitude	
				Start	End
Item	Encroachments			38.590917 °	38.590917 °
				-121.472245 °	-121.472245 °
DWR ID	DWR_NA0001_04_f _ 2019_236				
Comment Code					
GA : Garbage					
Inspector Comment					
Remove garbage located within the landside easement.

View of debris on the landside easement and other property. Fall 2019

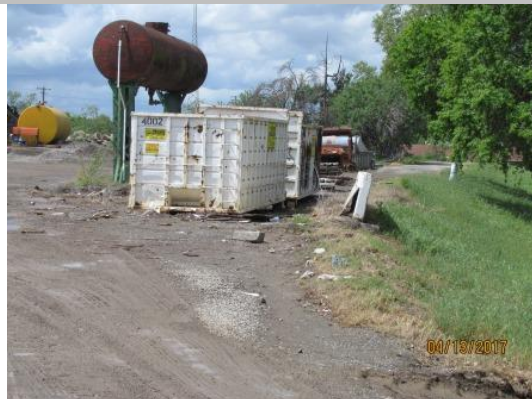
Photo 1 of 1 : SP\_2020\_NA0001\_55\_3\_20200302\_00002.jpg

LM Start	2.72	Rating **	U	Issue No.	3
LM End	2.86	Issue Type +	En	Location *	LS
Category	Earthen Levee			GPS Latitude/Longitude	
				Start	End
Item	Encroachments			38.587939 °	38.587299 °
				-121.466635 °	-121.464320 °
DWR ID	DWR_NA0001_04_s_2012_3				
Comment Code					
EQ : Equipment					
Inspector Comment					
The LMA sent a letter to the property owner (Bell Marine) for the violation. Equipment completely blocks the levee crown.

View of the equipment obstructing levee crown access. Spring 2017.

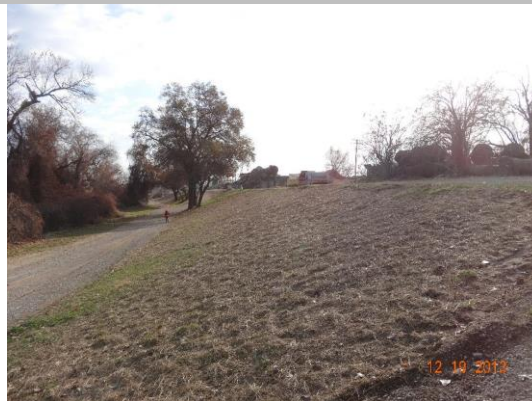
Photo 1 of 2 : UCIP\_SP\_2020\_31444\_57486.jpg

LM Start	2.77	Rating **	M	Issue No.	753
LM End	2.77	Issue Type +	En	Location *	
Category	Supplemental			GPS Latitude/Longitude	
				Start	End
Item	DWR UCIP Field Study			38.587629 °	38.587629 °
				-121.465905 °	-121.465905 °
DWR ID	24805				
Comment Code					
Inspector Comment					
DS_ID:24805 FS_ID:31444 EP_NO: N/A Repair Type: Non-Urgent Crossing Status: Indicator Found UCIP Comments: No permit (unauthorized crossing)--need additional information about crossing. FIELD_STRUCT_DESC: Standpipe located on waterside (WS) shoulder. Unable to confirm pipe alignment. No permit found. FS Date: 12/19/2013

View of waterward slope.

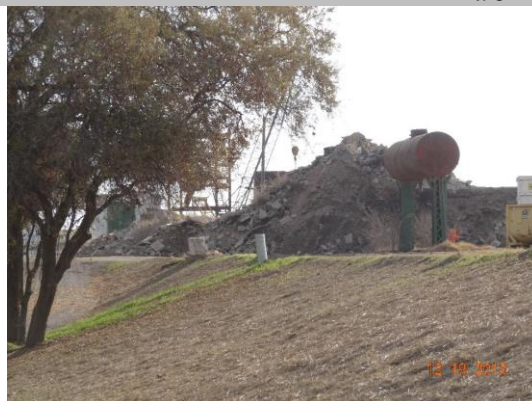
Photo 2 of 2 : UCIP\_SP\_2020\_31444\_57485.jpg

Standpipe located on waterward shoulder.

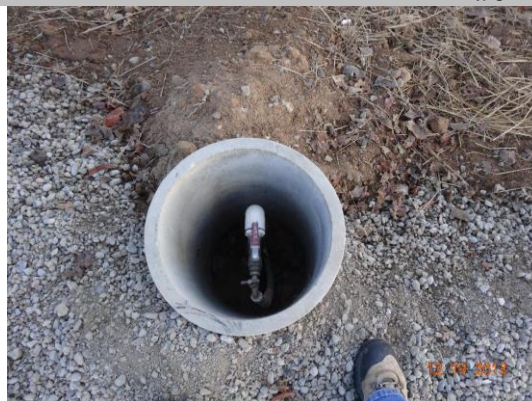
Photo 1 of 1 : UCIP\_SP\_2020\_31445\_57487.jpg

LM Start	2.82	Rating **	M	Issue No.	755	
LM End	2.82	Issue Type +	En	Location *		
Category	Supplemental			GPS Latitude/Longitude		
				Start	End	
Item	DWR UCIP Field Study			38.587438 °	38.587438 °	
				-121.464989 °	-121.464989 °	
DWR ID	24806					
Comment Code						
Inspector Comment						
DS_ID:24806						
FS_ID:31445						
EP_NO: N/A						
Repair Type: Non-Urgent						
Crossing Status: Found						
UCIP Comments: No permit found (unauthorized?)--need additional information about crossing.						
FIELD_STRUCT_DESC: Standpipe located on waterside (WS) shoulder. Pipe crosses levee crown and landside (LS). Pipe used for irrigation. No Permit found.						
FS Date: 12/13/2013

Spigot located inside riser located on waterward shoulder.

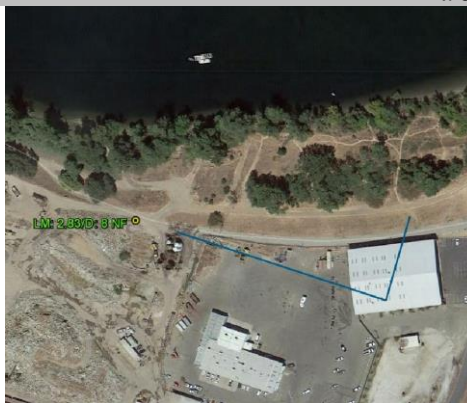
Photo 1 of 1 : UCIP\_SP\_2020\_31253\_57216.jpg

Comment Code					
Inspector Comment					
DS_ID:24328 FS_ID:31253 EP_NO: 5890 Repair Type: Non-Urgent Crossing Status: Not Found UCIP Comments: Need to contact owner to determine status of crossing--approximate alignment indicates pipe does not cross levee however records shows drain pipe crosses levee. FIELD_STRUCT_DESC: 8-inch corrugated metal drainage pipe through the levee, 2.1 feet below the crown. Concrete drop inlet structure at waterside (WS) shoulder. Maintenance facilities and yard on the landside (LS). Rock revetment on WS slope. (8-inch pipe authorized under Permit No. 5890, 1968 - City of Sacramento) [Additional Reference(s): DWR Levee Log, 2002. USACE Sacramento O&M Manual Unit 118 Part 1, August 1955, (Station 156+75)]. FS Date: 12/19/2013

Approximate alignment indicated in blue and approximate location indicated by DWR-UCIP in green label.

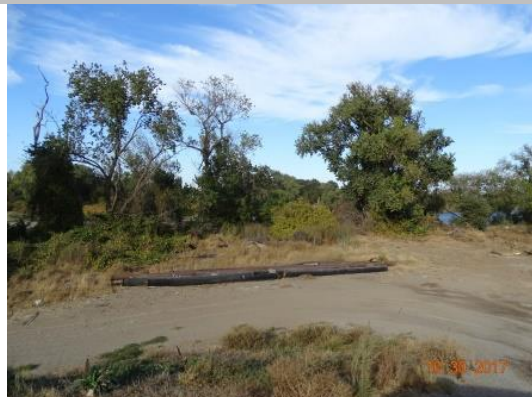
Photo 1 of 1 : SP\_2020\_NA0001\_55\_4\_20200302\_00003.jpg

LM Start	2.83	Rating **	M	Issue No.	4
LM End	2.83	Issue Type +	En	Location *	WS
Category	Earthen Levee			GPS Latitude/Longitude	
				Start	End
Item	Encroachments			38.587272 °	38.587272 °
				-121.464768 °	-121.464768 °
DWR ID	DWR_NA0001_04_s_2012_4				
Comment Code					
DE : Debris					
Inspector Comment					
Bell Marine staged the pipes to be moved when the water comes up.

View of the metal pipes in the floodway staged to be removed when the water rises to the top of the bank. Fall 2017

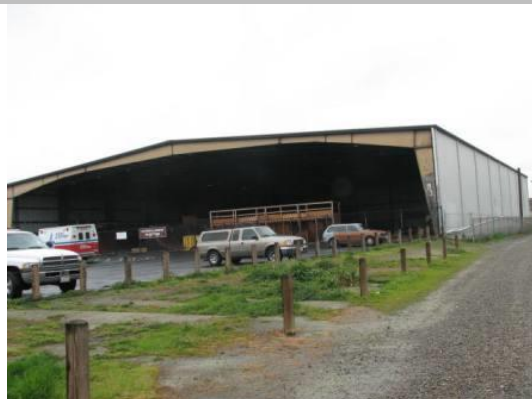
Photo 1 of 1 : SP\_2020\_NA0001\_55\_5\_20200302\_00004.jpg

LM Start	2.92	Rating **	U	Issue No.	5
LM End	2.96	Issue Type +	En	Location *	LS
Category	Earthen Levee			GPS Latitude/Longitude	
				Start	End
Item	Encroachments			38.587251 °	38.587318 °
				-121.463237 °	-121.462513 °
DWR ID	DWR_NA0001_04_s_2012_5				
Comment Code					
BU : Building					
Inspector Comment

03/16/2012 Sutter's Landing Skate Park.
